STUCCO & MASONRY

“Alligator-back” – Causes and Correction®

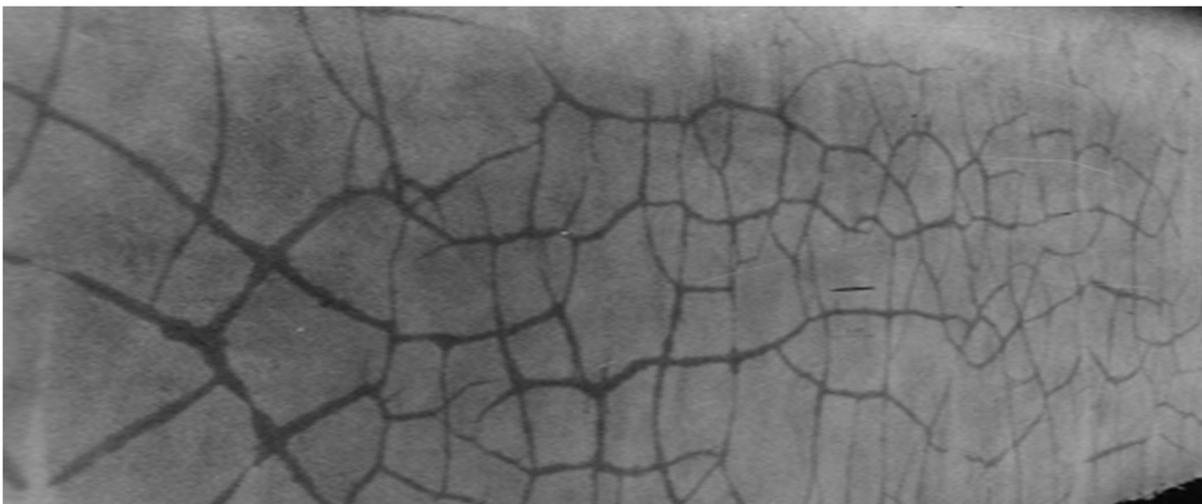
The crack pattern in the photo below is due to the reduction of volume due to rapid loss of water in the fresh plaster. This is a common and natural consequence. Most of this type of cracking is preventable by keeping the wall damp for several days after plastering.

Several factors may contribute to this loss. When fresh plaster is direct-applied to a solid substrate (concrete, block, stone, brick) the substrate is required to be dampened prior to plaster application to help prevent the type of cracks shown below.

Concrete block exit the plant in a still wet state. This volume of water makes the block as big as it will ever be. As soon as it is set in the yard it begins to shrink as it dries out. Then, when it is semi-dry it gets to the jobsite and is placed in the wall where it dries further. So, when wet plaster is placed on dry block, the block will absorb the moisture out of the plaster in an effort to satisfy its’ and the mortar joints’ thirst for water. This

reduces the volume of the plaster too rapidly for the plaster to retain its' original volume, thereby, causing a small shrinkage crack to appear.

These cracks are cosmetic in nature and, in most cases; do not penetrate the entire plaster thickness, just the finish coat. They therefore rarely pose any threat to the durability or water tightness of the plaster assembly.

Prevention can be as simple as dampening the wall prior to application of the plaster and fogging (moist curing) the wall several times per day for three to four days after application. Weather conditions can vary this requirement.

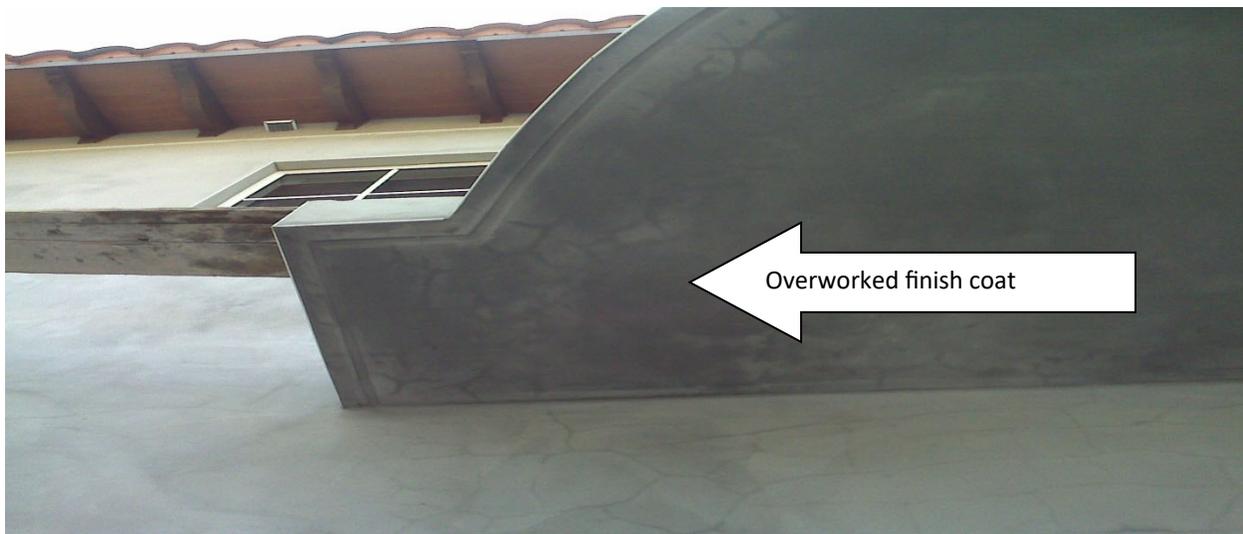
The photo below shows a similar issue on the underside of the overhead structure but with an added factor. It appears much the same as the cracking above but with much smaller "alligator-back" patterns. This condition is usually caused by overworking the plaster but can also be the result of too fine a sand. This happens when an area begins to reach initial set before the plasterer has had time to get it floated. Overworking causes the finest particles of sand to come to the surface producing a layer of plaster with all the same size aggregate. Plaster aggregate is necessarily of varying sizes to promote mechanical bonding within the plaster itself. This is very similar to overworking concrete.

It may be unwise to try to seal all of these cracks and it is generally considered inadvisable where cosmetics are the only reason for doing so. These minor cracks are usually more pronounced after a rain or on a foggy morning as the wall begins to dry out. Often, the repair of this type of crack is more visible than the crack itself. Usually, these cracks can be covered with a good primer and a high-solids latex paint. The owner should decide which direction to go.
