**G. MICHAEL STARKS**  
CGC, CDT, CCPR, LEED BD & C

May 2017

## “Alligator-back” – Causes and Correction®

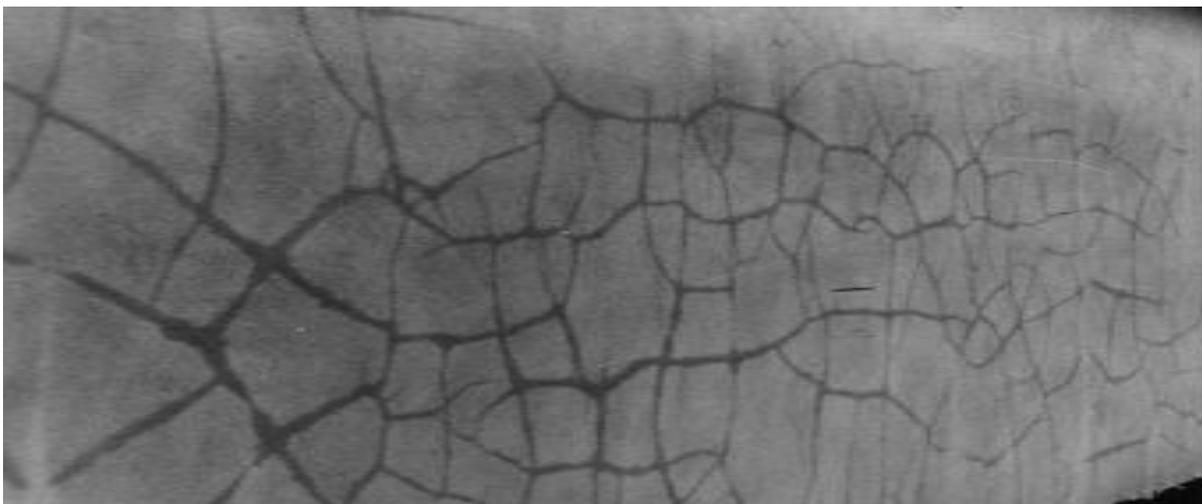
The crack pattern in the photo below is due to the reduction of volume due to rapid loss of water in the fresh plaster. This is a common and natural consequence. Most of this type of cracking is preventable by keeping the wall damp for several days after plastering.

Several factors may contribute to this loss. When fresh plaster is direct-applied to a solid substrate (concrete, block, stone, brick) the substrate is required to be dampened prior to plaster application to help prevent the type of cracks shown below..

Concrete block exit the plant in a still wet state. This volume of water makes the block as big as it will ever be. As soon as it is set in the yard it begins to shrink as it dries out. Then, when it is semi-dry it gets to the jobsite and is placed in the wall where it dries further. So, when wet plaster is placed on dry block, the block will absorb the moisture out of the plaster in an effort to satisfy its’ and the mortar joints’ thirst for water. This

reduces the volume of the plaster too rapidly for the plaster to retain its' original volume, thereby, causing a small shrinkage crack to appear.

These cracks are cosmetic in nature and, in most cases; do not penetrate the entire plaster thickness, just the finish coat. They therefore rarely pose any threat to the durability or water tightness of the plaster assembly.

Prevention can be as simple as dampening the wall prior to application of the plaster and fogging (moist curing) the wall several times per day for three to four days after application. Weather conditions can vary this requirement.

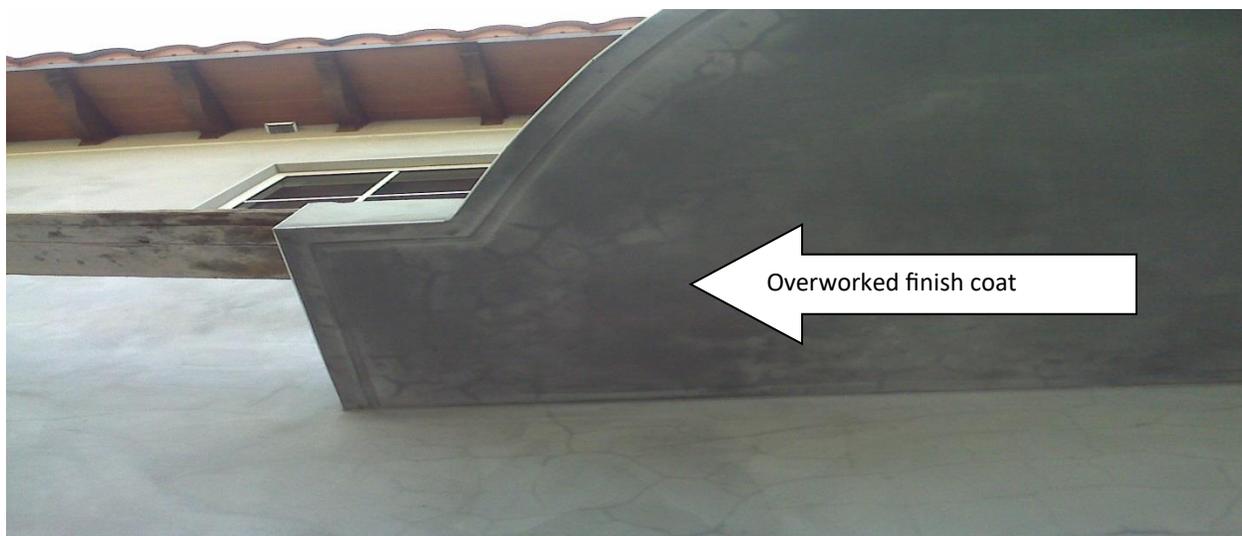
The photo below shows a similar issue on the underside of the overhead structure but with an added factor. It appears much the same as the cracking above but with much smaller "alligator-back" patterns. This condition is usually caused by overworking the plaster but can also be the result of too fine a sand. This happens when an area begins to reach initial set before the plasterer has had time to get it floated. Overworking causes the finest particles of sand to come to the surface producing a layer of plaster with all the same size aggregate. Plaster aggregate is necessarily of varying sizes to promote mechanical bonding within the plaster itself. This is very similar to overworking concrete.

It may be unwise to try to seal all of these cracks and it is generally considered inadvisable where cosmetics are the only reason for doing so. These minor cracks are usually more pronounced after a rain or on a foggy morning as the wall begins to dry out. Often, the repair of this type of crack is more visible than the crack itself. Usually, these cracks can be covered with a good primer and a high-solids latex paint. The owner should decide which direction to go.
